PRESERVATION ASSESSMENT AND PLAN FOR SPRINGWOOD CEMETERY, CITY OF GREENVILLE, S.C.

Prepared By:
Michael Trinkley, Ph.D.
and
Debi Hacker

CHICORA RESEARCH CONTRIBUTION 440

March 31, 2006

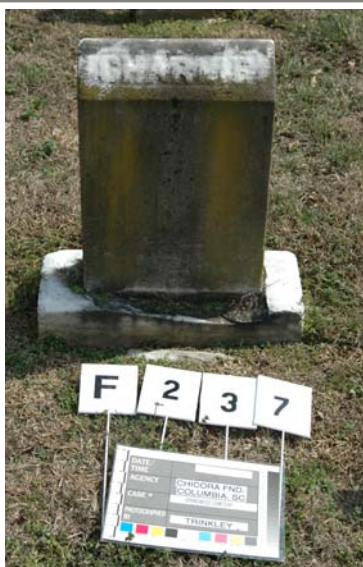
Position: ☐ fallen ☒ unstable ☒ tilted ☒ unattached/loose ☐ missing ☐ shifted

Deterioration: ☐ broken ☐ cracked ☐ losses ☐ flaking/sugaring ☒ ferrous pins
☐ delamination/detachment ☐ missing fragments ☐ other:

Soiling: ☒ biological ☐ staining ☐ efflorescence ☐ other:

Position: ☐ reset in ground ☒ reset/level to existing base ☐ construct new base
☐ possible new base required ☐ stabilize foundation ☐ resquare

Treatment: ☒ core drill ☒ drill and pin ☐ adhesive repair ☒ infill w/Jahn or U.S. Heritage
☐ injection grout ☐ replace bricks ☐ mortar ☐ repoint ☐ other:

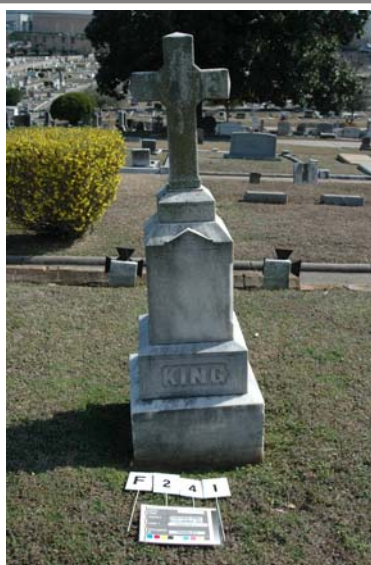
Position: ☐ fallen ☐ unstable ☒ tilted ☐ unattached/loose ☐ missing ☐ shifted

Deterioration: ☒ broken ☐ cracked ☐ losses ☐ flaking/sugaring ☐ ferrous pins
☐ delamination/detachment ☐ missing fragments ☐ other:

Soiling: ☒ biological ☐ staining ☐ efflorescence ☐ other:

Position: ☐ reset in ground ☒ reset/level to existing base ☐ construct new base
☐ possible new base required ☐ stabilize foundation ☐ resquare

Treatment: ☐ core drill ☒ drill and pin ☐ adhesive repair ☒ infill w/Jahn or U.S. Heritage
☐ injection grout ☐ replace bricks ☐ mortar ☐ repoint ☐ other:

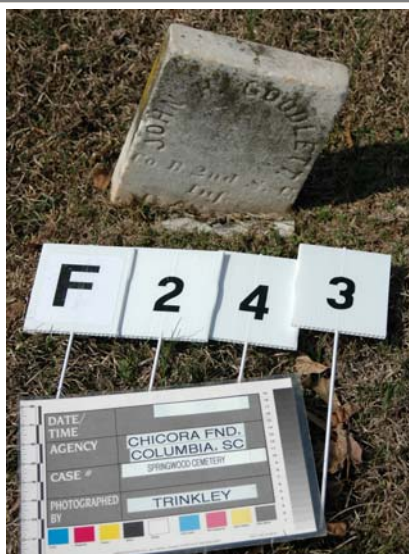
Position: ☐ fallen ☒ unstable ☐ tilted ☒ unattached/loose ☐ missing ☐ shifted

Deterioration: ☒ broken ☐ cracked ☒ losses ☐ flaking/sugaring ☐ ferrous pins
☐ delamination/detachment ☐ missing fragments ☐ other:

Soiling: ☒ biological ☐ staining ☐ efflorescence ☐ other:

Position: ☐ reset in ground ☒ reset/level to existing base ☐ construct new base
☐ possible new base required ☐ stabilize foundation ☐ resquare

Treatment: ☐ core drill ☒ drill and pin ☒ adhesive repair ☒ infill w/Jahn or U.S. Heritage
☐ injection grout ☐ replace bricks ☐ mortar ☐ repoint ☐ other:

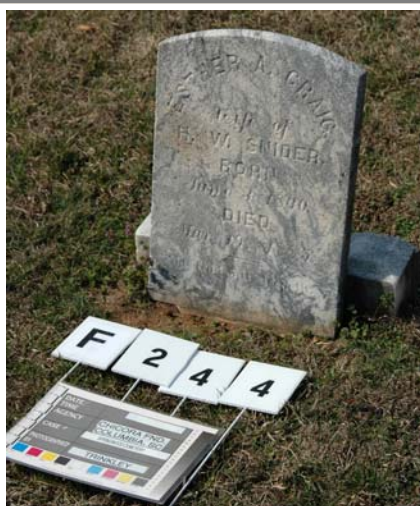
Position: ☐ fallen ☒ unstable ☐ tilted ☒ unattached/loose ☐ missing ☐ shifted

Deterioration: ☒ broken ☐ cracked ☒ losses ☐ flaking/sugaring ☐ ferrous pins
☐ delamination/detachment ☐ missing fragments ☐ other:

Soiling: ☒ biological ☐ staining ☐ efflorescence ☐ other:

Position: ☐ reset in ground ☒ reset/level to existing base ☐ construct new base
☐ possible new base required ☐ stabilize foundation ☐ resquare

Treatment: ☐ core drill ☒ drill and pin ☐ adhesive repair ☒ infill w/Jahn or U.S. Heritage
☐ injection grout ☐ replace bricks ☐ mortar ☐ repoint ☐ other:

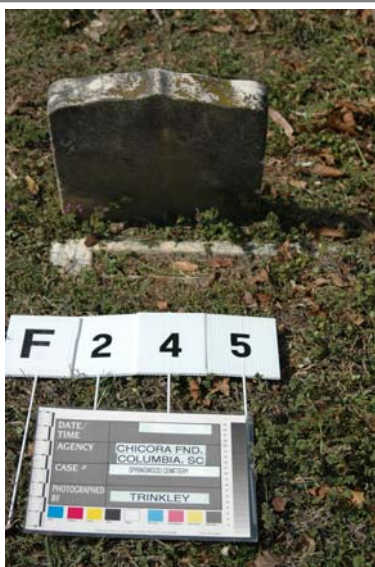
Position: ☐ fallen ☒ unstable ☐ tilted ☒ unattached/loose ☐ missing ☐ shifted

Deterioration: ☒ broken ☐ cracked ☐ losses ☐ flaking/sugaring ☐ ferrous pins
☐ delamination/detachment ☒ missing fragments ☐ other:

Soiling: ☒ biological ☐ staining ☐ efflorescence ☐ other:

Treatment: ☐ core drill ☒ drill and pin ☐ adhesive repair ☒ infill w/Jahn or U.S. Heritage
☐ injection grout ☐ replace bricks ☐ mortar ☐ repoint ☐ other:

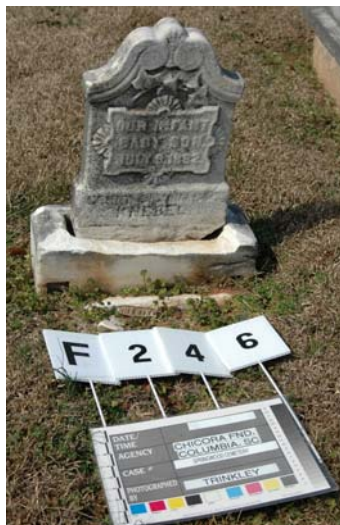
Position: ☐ fallen ☒ unstable ☒ tilted ☒ unattached/loose ☐ missing ☐ shifted

Deterioration: ☐ broken ☐ cracked ☐ losses ☐ flaking/sugaring ☒ ferrous pins
☐ delamination/detachment ☐ missing fragments ☐ other:

Soiling: ☒ biological ☐ staining ☐ efflorescence ☐ other:

Position: ☐ reset in ground ☒ reset/level to existing base ☐ construct new base
☐ possible new base required ☐ stabilize foundation ☐ resquare

Treatment: ☒ core drill ☒ drill and pin ☐ adhesive repair ☐ infill w/Jahn or U.S. Heritage
☐ injection grout ☐ replace bricks ☐ mortar ☐ repoint ☐ other:

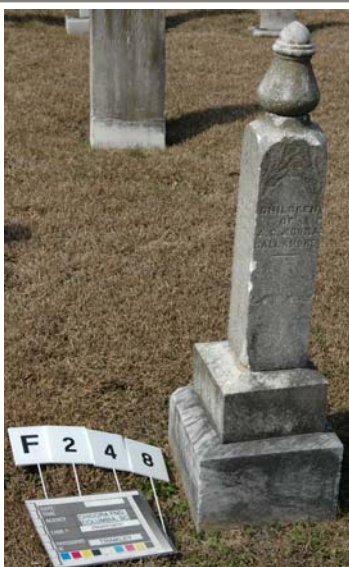
Position: ☐ fallen ☐ unstable ☒ tilted ☒ unattached/loose ☐ missing ☐ shifted

Soiling: ☒ biological ☐ staining ☐ efflorescence ☐ other:

Position: ☐ reset in ground ☒ reset/level to existing base ☐ construct new base
☐ possible new base required ☐ stabilize foundation ☐ resquare

Treatment: ☐ core drill ☐ drill and pin ☒ adhesive repair ☐ infill w/Jahn or U.S. Heritage
☐ injection grout ☐ replace bricks ☐ mortar ☐ repoint ☐ other:

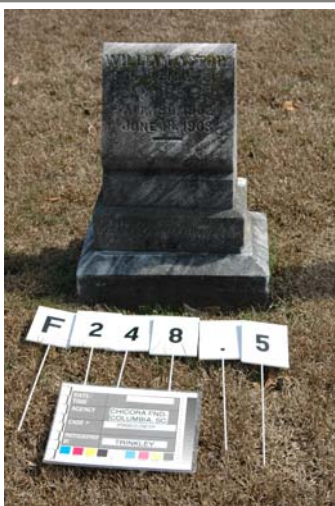
Position: ☒ fallen ☐ unstable ☐ tilted ☒ unattached/loose ☐ missing ☐ shifted

Position: ☐ reset in ground ☒ reset/level to existing base ☐ construct new base
☐ possible new base required ☐ stabilize foundation ☐ resquare

Treatment: ☒ core drill ☒ drill and pin ☐ adhesive repair ☐ infill w/Jahn or U.S. Heritage
☐ injection grout ☐ replace bricks ☐ mortar ☐ repoint ☐ other:

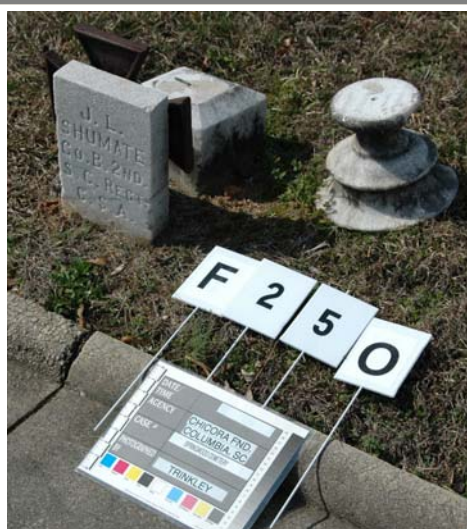
Position: ☒ fallen ☐ unstable ☐ tilted ☒ unattached/loose ☐ missing ☐ shifted

Deterioration: ☒ broken ☐ cracked ☒ losses ☒ flaking/sugaring ☐ ferrous pins
☐ delamination/detachment ☐ missing fragments ☐ other:

Soiling: ☒ biological ☐ staining ☐ efflorescence ☐ other:

Position: ☐ reset in ground ☒ reset/level to existing base ☐ construct new base
☐ possible new base required ☐ stabilize foundation ☐ resquare

Treatment: ☒ core drill ☒ drill and pin ☐ adhesive repair ☒ infill w/Jahn or U.S. Heritage
☐ injection grout ☐ replace bricks ☐ mortar ☐ repoint ☐ other:

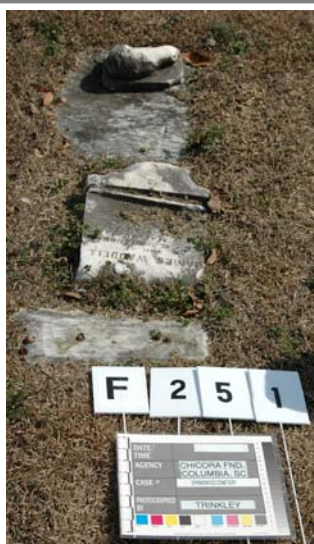
Position: ☐ fallen ☒ unstable ☐ tilted ☒ unattached/loose ☐ missing ☐ shifted

Deterioration: ☒ broken ☒ cracked ☐ losses ☐ flaking/sugaring ☒ ferrous pins
☐ delamination/detachment ☐ missing fragments ☐ other:

Soiling: ☒ biological ☐ staining ☐ efflorescence ☐ other:

Position: ☐ reset in ground ☒ reset/level to existing base ☐ construct new base
☐ possible new base required ☐ stabilize foundation ☐ resquare

Treatment: ☒ core drill ☒ drill and pin ☐ adhesive repair ☒ infill w/Jahn or U.S. Heritage
☐ injection grout ☐ replace bricks ☐ mortar ☐ repoint ☐ other:

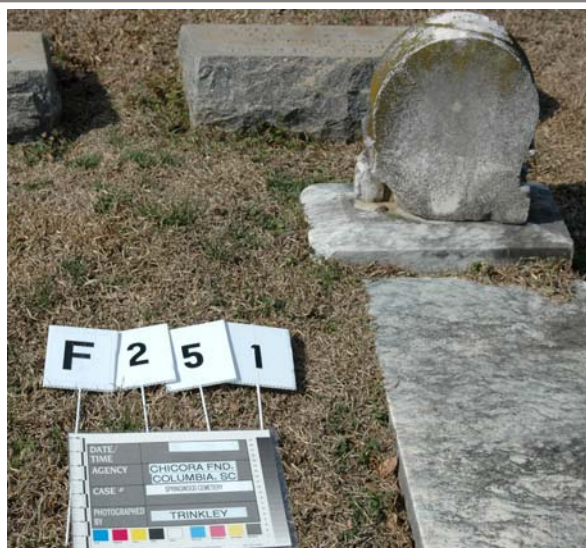
Position: ☐ fallen ☒ unstable ☐ tilted ☒ unattached/loose ☐ missing ☐ shifted

Deterioration: ☐ broken ☐ cracked ☐ losses ☐ flaking/sugaring ☒ ferrous pins
☐ delamination/detachment ☐ missing fragments ☐ other:

Soiling: ☒ biological ☐ staining ☐ efflorescence ☐ other:

Position: ☐ reset in ground ☒ reset/level to existing base ☐ construct new base
☐ possible new base required ☐ stabilize foundation ☐ resquare

Treatment: ☒ core drill ☒ drill and pin ☐ adhesive repair ☒ infill w/Jahn or U.S. Heritage
☐ injection grout ☐ replace bricks ☐ mortar ☐ repoint ☐ other:

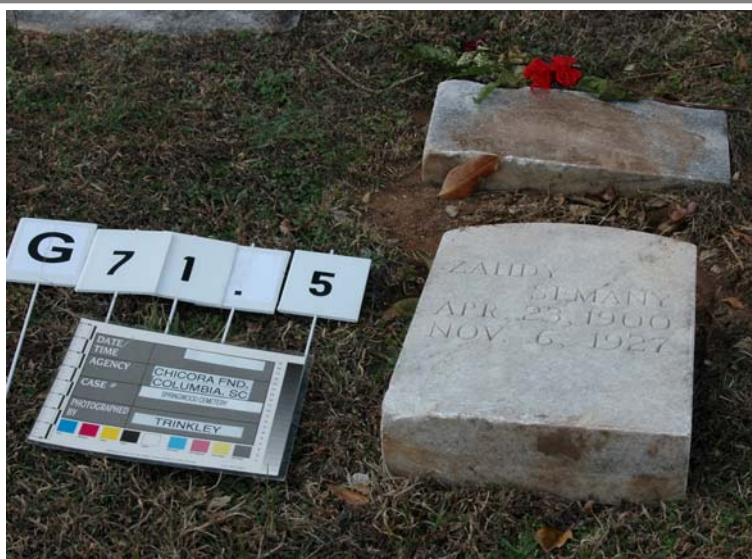
Position: ☒ fallen ☐ unstable ☒ tilted ☒ unattached/loose ☐ missing ☐ shifted

Soiling: ☒ biological ☐ staining ☐ efflorescence ☐ other:

Position: ☐ reset in ground ☒ reset/level to existing base ☐ construct new base
☐ possible new base required ☒ stabilize foundation ☐ resquare

Treatment: ☐ core drill ☒ drill and pin ☐ adhesive repair ☐ infill w/Jahn or U.S. Heritage
☐ injection grout ☐ replace bricks ☐ mortar ☐ repoint ☐ other:

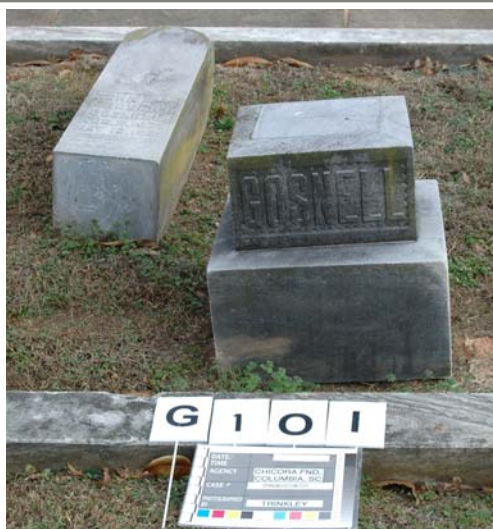
Position: ☒ fallen ☐ unstable ☐ tilted ☒ unattached/loose ☐ missing ☐ shifted

Position: ☐ reset in ground ☒ reset/level to existing base ☐ construct new base
☐ possible new base required ☐ stabilize foundation ☐ resquare

Treatment: ☐ core drill ☒ drill and pin ☐ adhesive repair ☐ infill w/Jahn or U.S. Heritage
☐ injection grout ☐ replace bricks ☐ mortar ☐ repoint ☐ other:

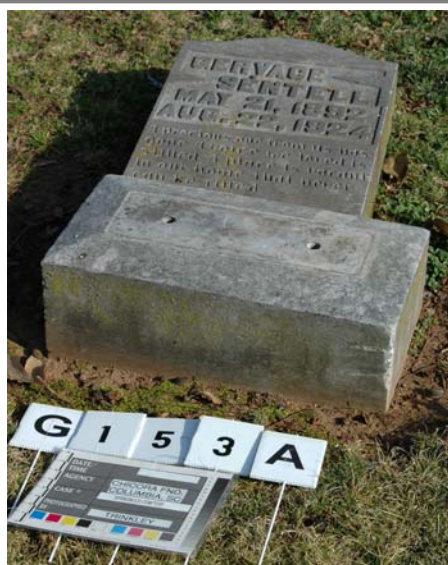
Position: ☒ fallen ☐ unstable ☐ tilted ☒ unattached/loose ☐ missing ☐ shifted

Failed/Old Treatments: ☐ metal ☐ adhesives/coatings ☒ mortar ☐ other:

Soiling: ☒ biological ☐ staining ☐ efflorescence ☐ other:

Position: ☐ reset in ground ☒ reset/level to existing base ☐ construct new base
☐ possible new base required ☐ stabilize foundation ☐ resquare

Failed Treatments: ☐ drill/grind ☒ hand tools ☐ solvents ☐ other:

Treatment: ☐ core drill ☒ drill and pin ☐ adhesive repair ☐ infill w/Jahn or U.S. Heritage
☐ injection grout ☐ replace bricks ☐ mortar ☐ repoint ☐ other:

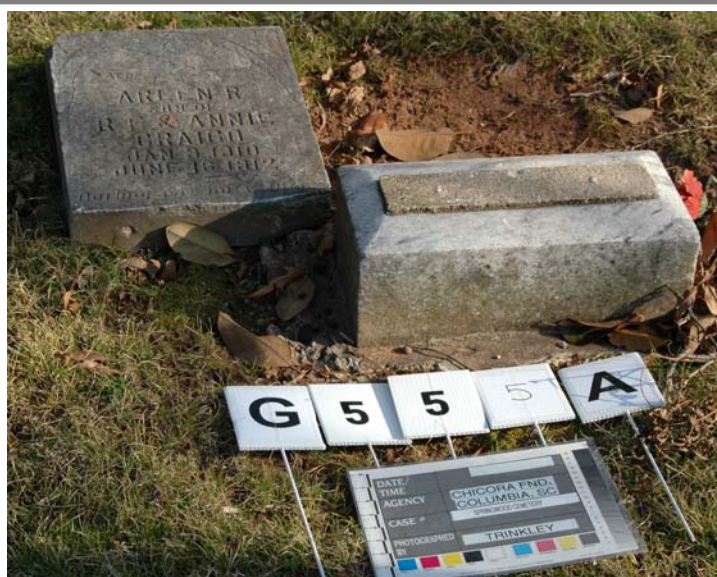
Position: ☐ fallen ☐ unstable ☐ tilted ☒ unattached/loose ☐ missing ☐ shifted

Deterioration: ☒ broken ☐ cracked ☐ losses ☐ flaking/sugaring ☐ ferrous pins
☐ delamination/detachment ☐ missing fragments ☐ other:

Soiling: ☒ biological ☐ staining ☐ efflorescence ☐ other:

Position: ☐ reset in ground ☒ reset/level to existing base ☐ construct new base
☐ possible new base required ☐ stabilize foundation ☐ resquare

Treatment: ☐ core drill ☒ drill and pin ☐ adhesive repair ☒ infill w/Jahn or U.S. Heritage
☐ injection grout ☐ replace bricks ☐ mortar ☐ repoint ☐ other:

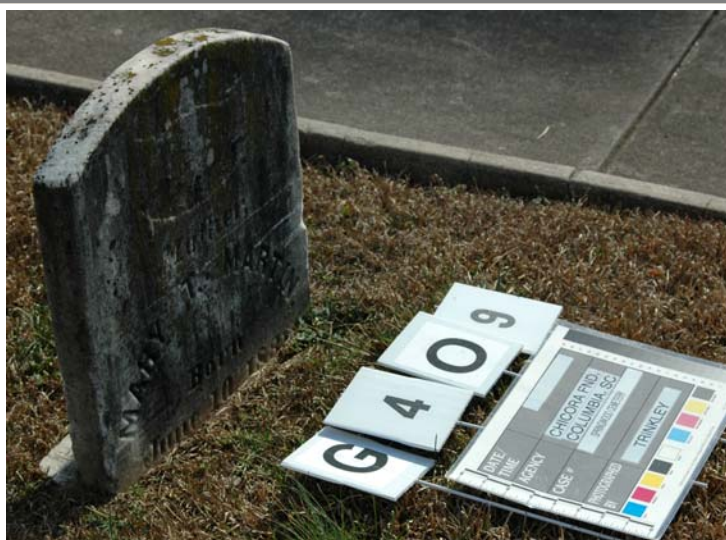
Position: ☐ fallen ☒ unstable ☒ tilted ☒ unattached/loose ☐ missing ☐ shifted

Soiling: ☒ biological ☐ staining ☐ efflorescence ☐ other:

Position: ☐ reset in ground ☒ reset/level to existing base ☐ construct new base
☐ possible new base required ☒ stabilize foundation ☐ resquare

Treatment: ☐ core drill ☒ drill and pin ☐ adhesive repair ☐ infill w/Jahn or U.S. Heritage
☐ injection grout ☐ replace bricks ☐ mortar ☐ repoint ☐ other:

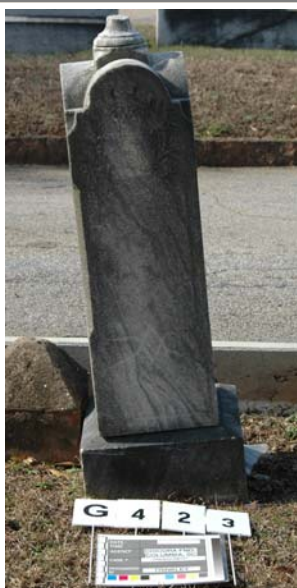
Position: ☒ fallen ☐ unstable ☐ tilted ☒ unattached/loose ☐ missing ☒ shifted

Failed/Old Treatments: ☐ metal ☐ adhesives/coatings ☒ mortar ☐ other:

Soiling: ☒ biological ☐ staining ☐ efflorescence ☐ other:

Position: ☐ reset in ground ☒ reset/level to existing base ☐ construct new base
☐ possible new base required ☐ stabilize foundation ☐ resquare

Failed Treatments: ☐ drill/grind ☒ hand tools ☐ solvents ☐ other:

Treatment: ☒ core drill ☒ drill and pin ☒ adhesive repair ☐ infill w/Jahn or U.S. Heritage
☐ injection grout ☐ replace bricks ☐ mortar ☐ repoint ☐ other:

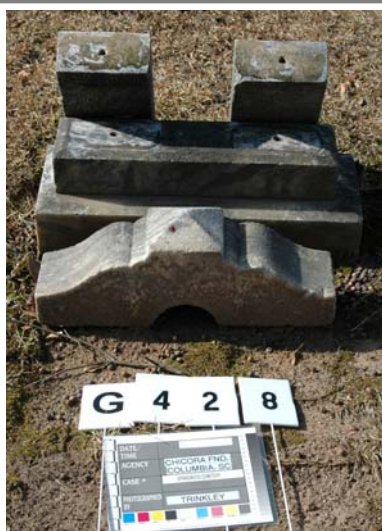
Position: ☒ fallen ☐ unstable ☐ tilted ☒ unattached/loose ☐ missing ☐ shifted

Deterioration: ☐ broken ☐ cracked ☒ losses ☐ flaking/sugaring ☐ ferrous pins
☐ delamination/detachment ☐ missing fragments ☒ other: socket missing

Soiling: ☒ biological ☐ staining ☐ efflorescence ☐ other:

Position: ☐ reset in ground ☒ reset/level to existing base ☒ construct new base
☐ possible new base required ☐ stabilize foundation ☐ resquare

Treatment: ☐ core drill ☐ drill and pin ☐ adhesive repair ☐ infill w/Jahn or U.S. Heritage
☐ injection grout ☐ replace bricks ☒ mortar ☐ repoint ☐ other:

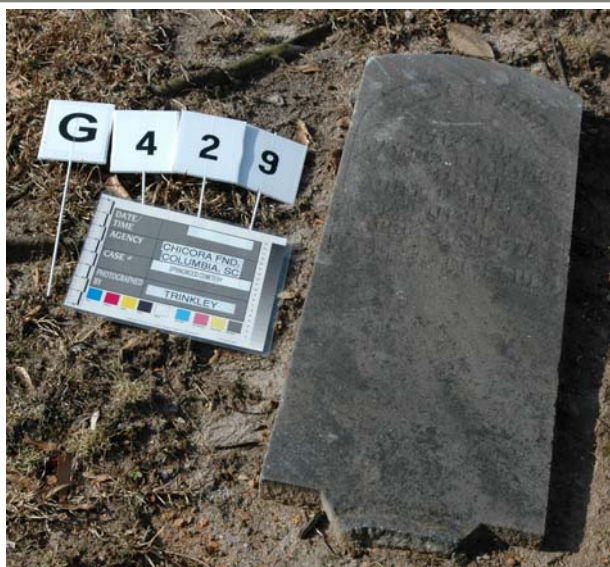
Position: ☐ fallen ☒ unstable ☐ tilted ☒ unattached/loose ☐ missing ☒ shifted

Soiling: ☒ biological ☐ staining ☐ efflorescence ☐ other:

Position: ☐ reset in ground ☒ reset/level to existing base ☐ construct new base
☐ possible new base required ☐ stabilize foundation ☐ resquare

Treatment: ☐ core drill ☒ drill and pin ☐ adhesive repair ☐ infill w/Jahn or U.S. Heritage
☐ injection grout ☐ replace bricks ☐ mortar ☐ repoint ☐ other:

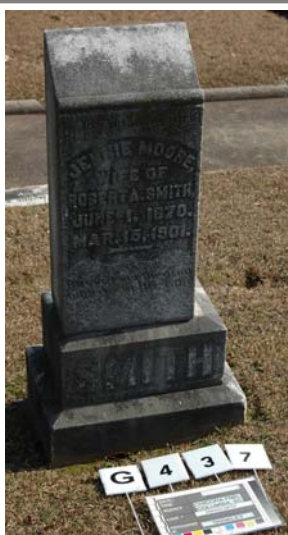
Position: ☐ fallen ☒ unstable ☒ tilted ☒ unattached/loose ☐ missing ☒ shifted

Soiling: ☒ biological ☐ staining ☐ efflorescence ☐ other:

Position: ☐ reset in ground ☒ reset/level to existing base ☐ construct new base
☐ possible new base required ☒ stabilize foundation ☐ resquare

Treatment: ☐ core drill ☒ drill and pin ☐ adhesive repair ☐ infill w/Jahn or U.S. Heritage
☐ injection grout ☐ replace bricks ☐ mortar ☐ repoint ☐ other:

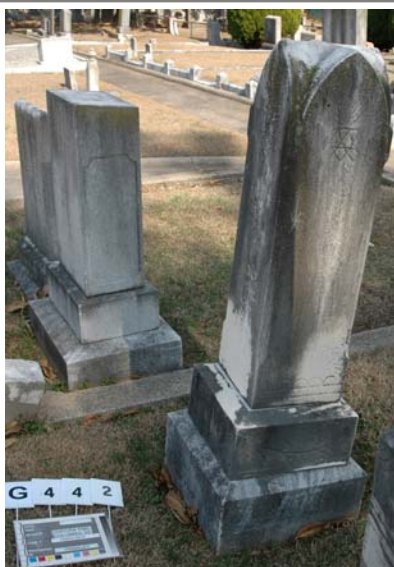
Position: ☒ fallen ☐ unstable ☐ tilted ☒ unattached/loose ☐ missing ☐ shifted

Soiling: ☒ biological ☐ staining ☐ efflorescence ☐ other:

Position: ☐ reset in ground ☒ reset/level to existing base ☐ construct new base
☐ possible new base required ☐ stabilize foundation ☐ resquare

Treatment: ☐ core drill ☒ drill and pin ☐ adhesive repair ☐ infill w/Jahn or U.S. Heritage
☐ injection grout ☐ replace bricks ☐ mortar ☐ repoint ☐ other:

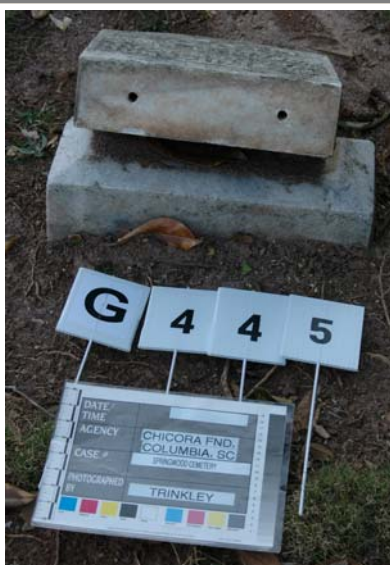
Position: ☒ fallen ☐ unstable ☒ tilted ☒ unattached/loose ☐ missing ☐ shifted

Soiling: ☒ biological ☐ staining ☐ efflorescence ☐ other:

Position: ☐ reset in ground ☒ reset/level to existing base ☐ construct new base
☐ possible new base required ☒ stabilize foundation ☐ resquare

Treatment: ☐ core drill ☒ drill and pin ☐ adhesive repair ☐ infill w/Jahn or U.S. Heritage
☐ injection grout ☐ replace bricks ☐ mortar ☐ repoint ☐ other:

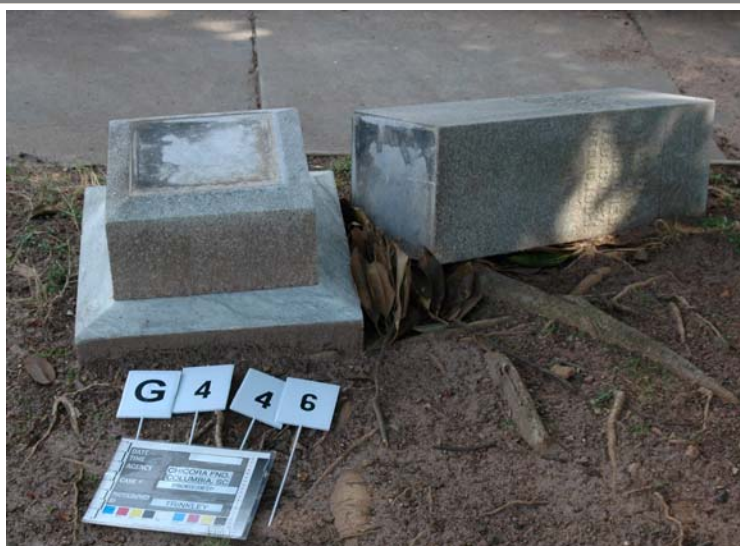
Position: ☒ fallen ☐ unstable ☐ tilted ☐ unattached/loose ☐ missing ☐ shifted

Deterioration: ☒ broken ☐ cracked ☐ losses ☐ flaking/sugaring ☐ ferrous pins
☐ delamination/detachment ☒ missing fragments ☐ other:

Treatment: ☐ core drill ☒ drill and pin ☒ adhesive repair ☐ infill w/Jahn or U.S. Heritage
☐ injection grout ☐ replace bricks ☐ mortar ☒ repoint ☐ other:

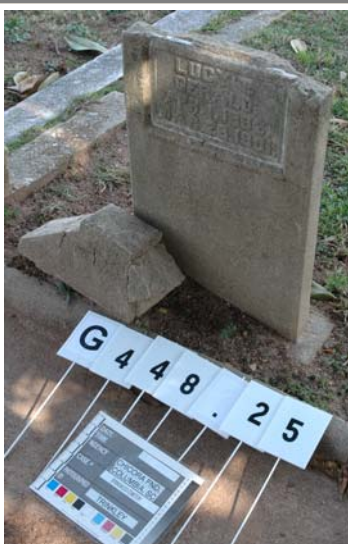
Position: ☒ fallen ☐ unstable ☐ tilted ☒ unattached/loose ☐ missing ☐ shifted

Soiling: ☒ biological ☐ staining ☐ efflorescence ☐ other:

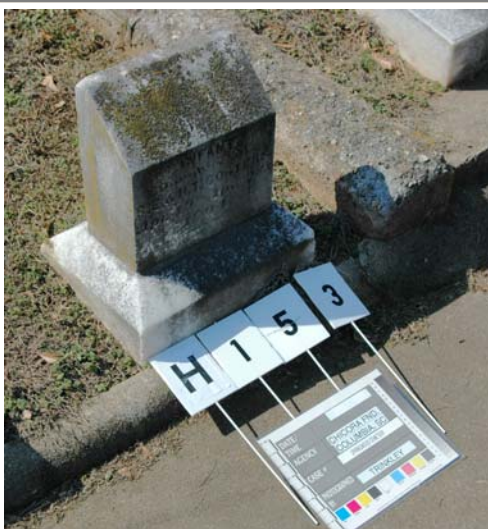
Position: ☐ fallen ☐ unstable ☐ tilted ☒ unattached/loose ☐ missing ☒ shifted

Deterioration: ☐ broken ☐ cracked ☐ losses ☐ flaking/sugaring ☐ ferrous pins
☐ delamination/detachment ☐ missing fragments ☐ other:

Soiling: ☒ biological ☐ staining ☐ efflorescence ☐ other:

Position: ☐ reset in ground ☒ reset/level to existing base ☐ construct new base
☐ possible new base required ☐ stabilize foundation ☐ resquare

Treatment: ☐ core drill ☐ drill and pin ☒ adhesive repair ☐ infill w/Jahn or U.S. Heritage
☐ injection grout ☐ replace bricks ☐ mortar ☐ repoint ☐ other:

Cost: \$150

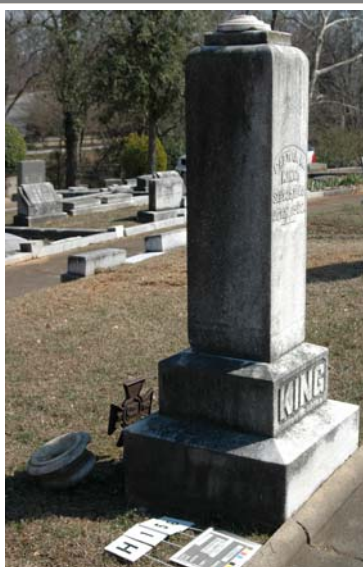
Position: ☐ fallen ☐ unstable ☐ tilted ☒ unattached/loose ☐ missing ☐ shifted

Deterioration: ☒ broken ☐ cracked ☐ losses ☐ flaking/sugaring ☐ ferrous pins
☐ delamination/detachment ☐ missing fragments ☒ other: urn only

Soiling: ☒ biological ☐ staining ☐ efflorescence ☐ other:

Position: ☐ reset in ground ☒ reset/level to existing base ☐ construct new base
☐ possible new base required ☐ stabilize foundation ☐ resquare

Treatment: ☐ core drill ☐ drill and pin ☒ adhesive repair ☐ infill w/Jahn or U.S. Heritage
☐ injection grout ☐ replace bricks ☐ mortar ☐ repoint ☐ other:

Cost: \$150

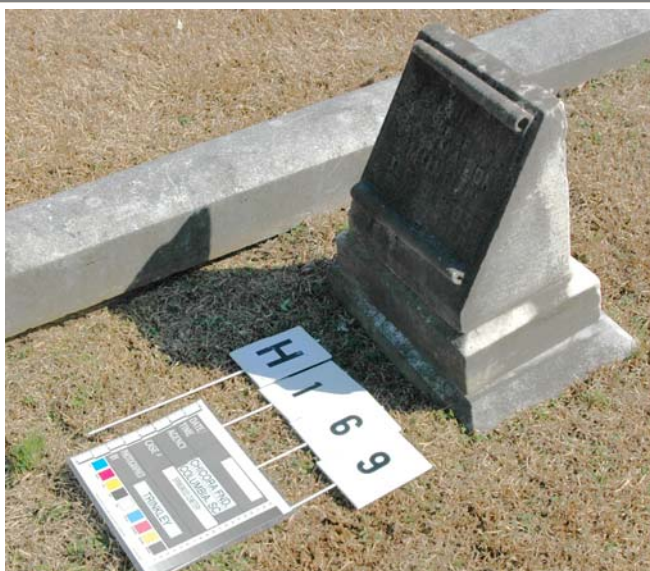
Position: ☐ fallen ☐ unstable ☒ tilted ☒ unattached/loose ☐ missing ☒ shifted

Soiling: ☒ biological ☐ staining ☐ efflorescence ☐ other:

Position: ☐ reset in ground ☒ reset/level to existing base ☐ construct new base
☐ possible new base required ☒ stabilize foundation ☐ resquare

Treatment: ☐ core drill ☐ drill and pin ☒ adhesive repair ☐ infill w/Jahn or U.S. Heritage
☐ injection grout ☐ replace bricks ☐ mortar ☐ repoint ☐ other:

Cost: \$200

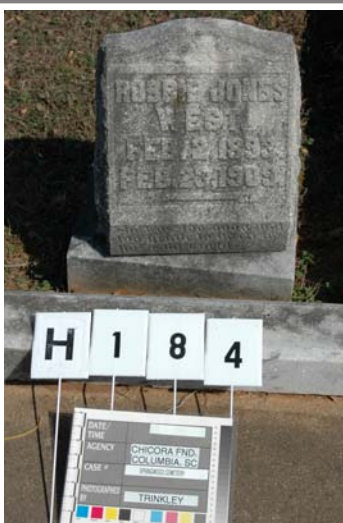
Position: ☐ fallen ☐ unstable ☐ tilted ☒ unattached/loose ☐ missing ☒ shifted

Soiling: ☒ biological ☐ staining ☐ efflorescence ☐ other:

Position: ☐ reset in ground ☒ reset/level to existing base ☐ construct new base
☐ possible new base required ☐ stabilize foundation ☐ resquare

Treatment: ☐ core drill ☐ drill and pin ☒ adhesive repair ☐ infill w/Jahn or U.S. Heritage
☐ injection grout ☐ replace bricks ☐ mortar ☐ repoint ☐ other:

Cost: \$150

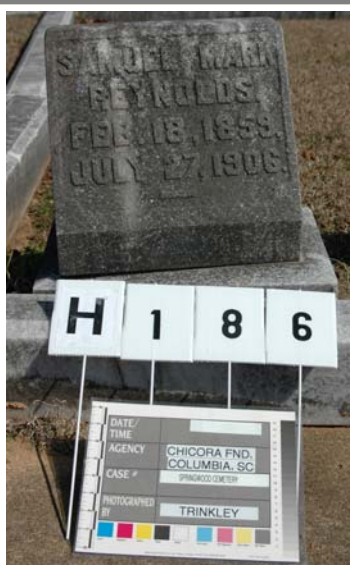
Position: ☐ fallen ☐ unstable ☐ tilted ☒ unattached/loose ☐ missing ☒ shifted

Soiling: ☒ biological ☐ staining ☐ efflorescence ☐ other:

Position: ☐ reset in ground ☒ reset/level to existing base ☐ construct new base
☐ possible new base required ☐ stabilize foundation ☐ resquare

Treatment: ☐ core drill ☐ drill and pin ☒ adhesive repair ☐ infill w/Jahn or U.S. Heritage
☐ injection grout ☐ replace bricks ☐ mortar ☐ repoint ☐ other:

Cost: \$150

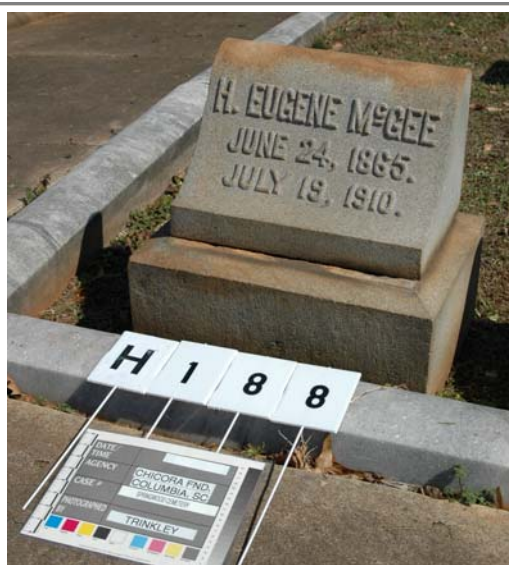
Position: ☐ fallen ☐ unstable ☐ tilted ☒ unattached/loose ☐ missing ☒ shifted

Soiling: ☐ biological ☒ staining ☐ efflorescence ☐ other:

Position: ☐ reset in ground ☒ reset/level to existing base ☐ construct new base
☐ possible new base required ☐ stabilize foundation ☐ resquare

Treatment: ☐ core drill ☐ drill and pin ☒ adhesive repair ☐ infill w/Jahn or U.S. Heritage
☐ injection grout ☐ replace bricks ☐ mortar ☐ repoint ☐ other:

Cost: \$150

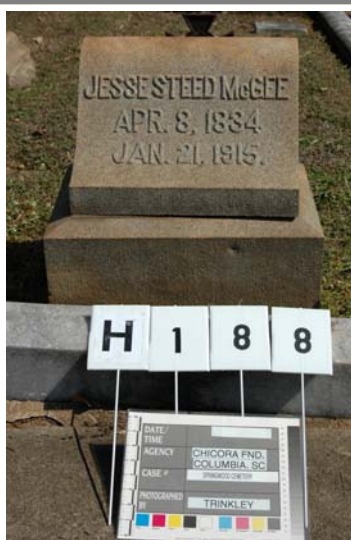
Position: ☐ fallen ☐ unstable ☐ tilted ☒ unattached/loose ☐ missing ☒ shifted

Soiling: ☐ biological ☒ staining ☐ efflorescence ☐ other:

Position: ☐ reset in ground ☒ reset/level to existing base ☐ construct new base
☐ possible new base required ☐ stabilize foundation ☐ resquare

Treatment: ☐ core drill ☐ drill and pin ☒ adhesive repair ☐ infill w/Jahn or U.S. Heritage
☐ injection grout ☐ replace bricks ☐ mortar ☐ repoint ☐ other:

Cost: \$150

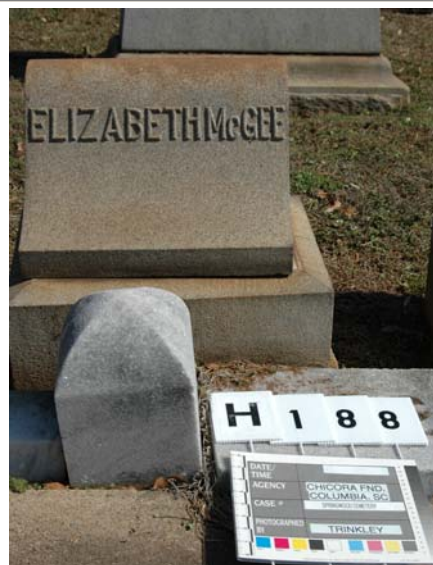
Position: ☐ fallen ☐ unstable ☐ tilted ☒ unattached/loose ☐ missing ☐ shifted

Soiling: ☐ biological ☒ staining ☐ efflorescence ☐ other:

Position: ☐ reset in ground ☒ reset/level to existing base ☐ construct new base
☐ possible new base required ☐ stabilize foundation ☐ resquare

Treatment: ☐ core drill ☐ drill and pin ☒ adhesive repair ☐ infill w/Jahn or U.S. Heritage
☐ injection grout ☐ replace bricks ☐ mortar ☐ repoint ☐ other:

Cost: \$150

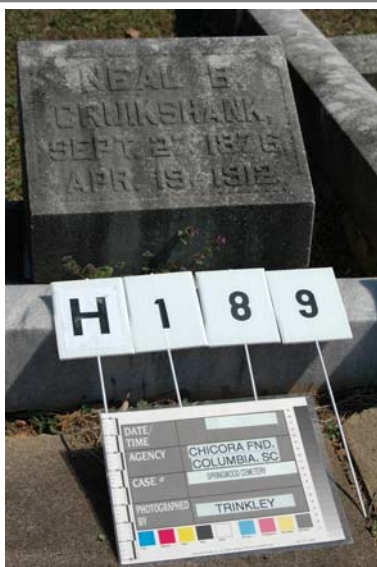
Position: ☐ fallen ☐ unstable ☐ tilted ☒ unattached/loose ☐ missing ☒ shifted

Soiling: ☒ biological ☐ staining ☐ efflorescence ☐ other:

Position: ☐ reset in ground ☒ reset/level to existing base ☐ construct new base
☐ possible new base required ☐ stabilize foundation ☐ resquare

Treatment: ☐ core drill ☐ drill and pin ☒ adhesive repair ☐ infill w/Jahn or U.S. Heritage
☐ injection grout ☐ replace bricks ☐ mortar ☐ repoint ☐ other:

Cost: \$150

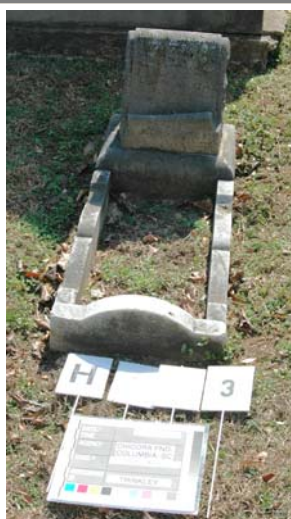
Position: ☐ fallen ☐ unstable ☐ tilted ☒ unattached/loose ☐ missing ☐ shifted

Soiling: ☒ biological ☐ staining ☐ efflorescence ☐ other:

Position: ☐ reset in ground ☒ reset/level to existing base ☐ construct new base
☐ possible new base required ☒ stabilize foundation ☐ resquare

Treatment: ☐ core drill ☐ drill and pin ☒ adhesive repair ☐ infill w/Jahn or U.S. Heritage
☐ injection grout ☐ replace bricks ☐ mortar ☐ repoint ☐ other:

Cost: \$250

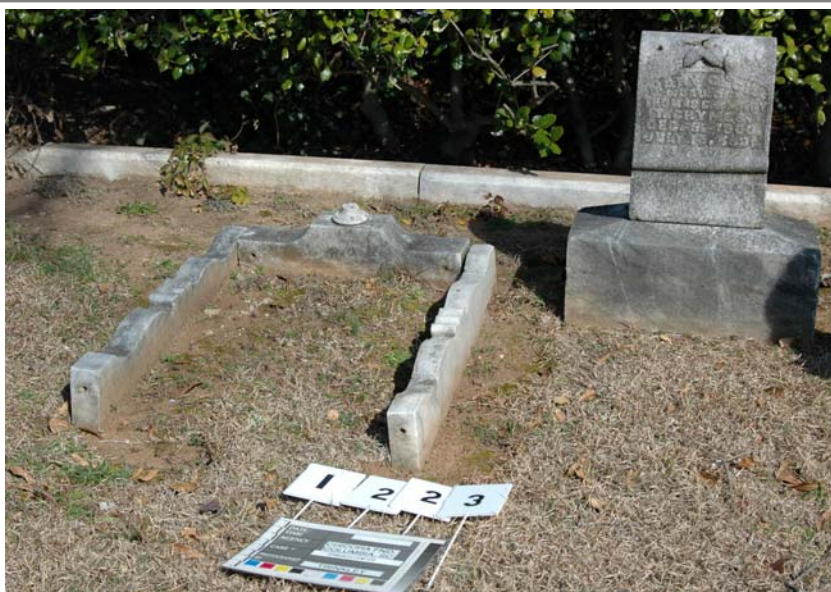
Position: ☐ fallen ☐ unstable ☐ tilted ☒ unattached/loose ☐ missing

Soiling: ☒ biological ☐ staining ☐ efflorescence ☐ other:

Position: ☐ reset in ground ☒ reset/level to existing base ☐ construct new base
☐ possible new base required ☐ stabilize foundation ☒ resquare

Treatment: ☐ core drill ☒ drill and pin ☐ adhesive repair ☐ infill w/Jahn or U.S. Heritage
☐ injection grout ☐ replace bricks ☐ mortar ☐ repoint ☐ other:

Cost: \$700

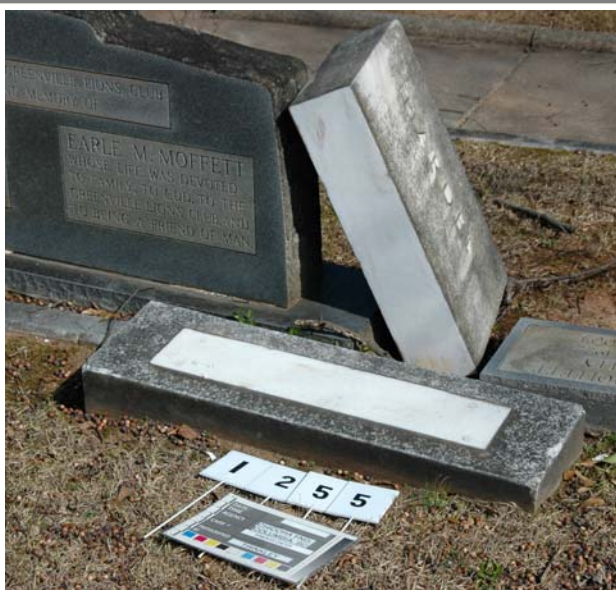
Position: ☒ fallen ☐ unstable ☐ tilted ☐ unattached/loose ☐ missing

Soiling: ☒ biological ☐ staining ☐ efflorescence ☐ other:

Position: ☐ reset in ground ☒ reset/level to existing base ☐ construct new base
☐ possible new base required ☐ stabilize foundation ☐ resquare

Treatment: ☐ core drill ☐ drill and pin ☒ adhesive repair ☐ infill w/Jahn or U.S. Heritage
☐ injection grout ☐ replace bricks ☐ mortar ☐ repoint ☐ other:

Cost: \$400

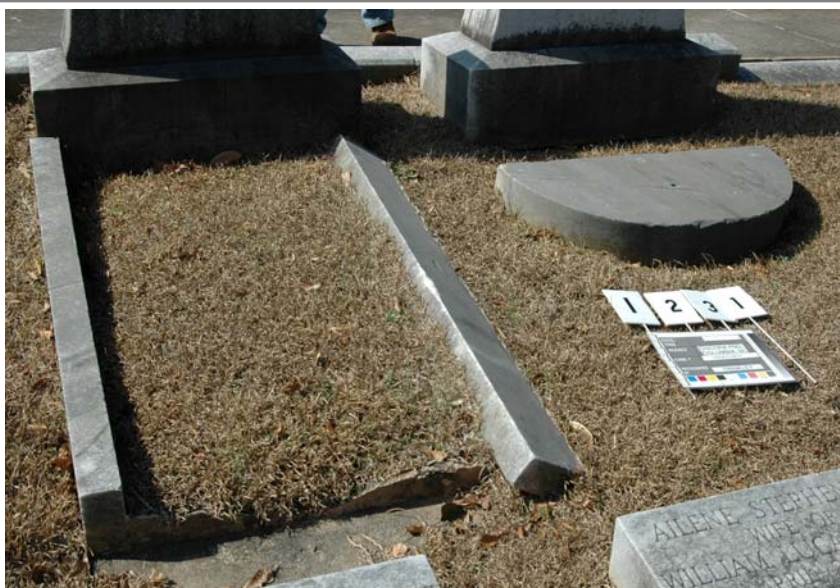
Position: ☒ fallen ☐ unstable ☐ tilted ☒ unattached/loose ☐ missing

Cost: \$450

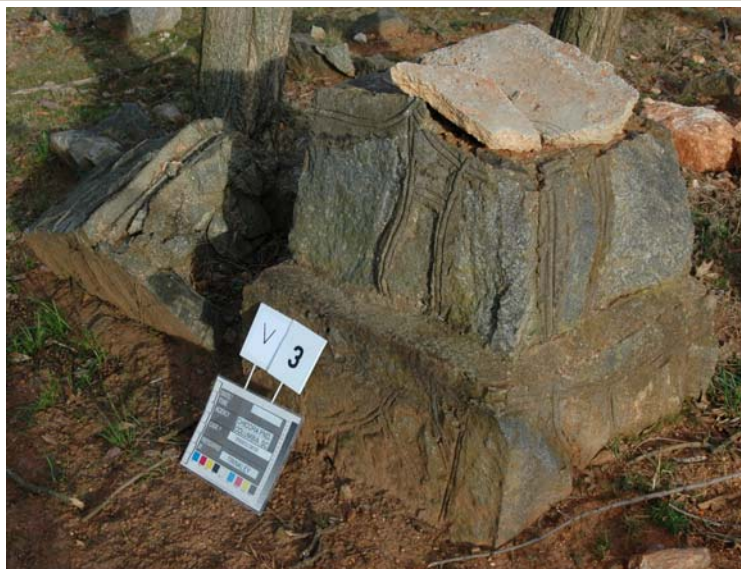
Type: ☐ headstone ☐ footstone ☐ die on base ☐ tab in socket ☐ box ☒ other: rustic obelisk

Position: ☒ fallen ☐ unstable ☐ tilted ☐ unattached/loose ☐ missing

Treatment: ☐ core drill ☐ drill and pin ☐ simple adhesive repair ☐ injection grout
☐ replace bricks ☐ mortar ☒ repoint ☒ other: remove mortar and reset top

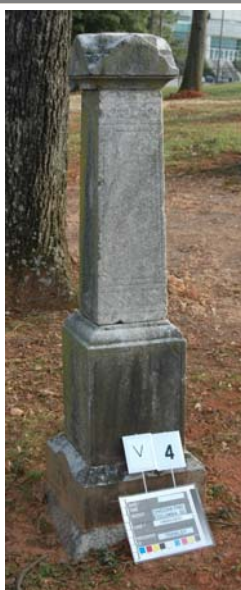
Position: ☐ fallen ☒ unstable ☐ tilted ☒ unattached/loose ☐ missing

Soiling: ☒ biological ☐ staining ☐ efflorescence ☐ other:

Position: ☐ reset in ground ☒ reset/level to existing base ☐ construct new base
☐ possible new base required ☐ stabilize foundation ☐ resquare

Treatment: ☐ core drill ☒ drill and pin ☐ simple adhesive repair ☐ injection grout
☐ replace bricks ☐ mortar ☐ repoint ☐ other:

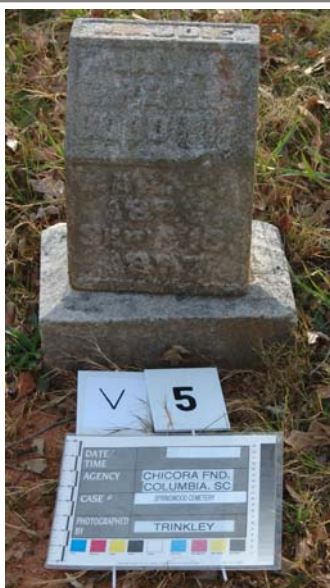
Position: ☐ fallen ☐ unstable ☒ tilted ☒ unattached/loose ☐ missing

Soiling: ☒ biological ☐ staining ☐ efflorescence ☐ other:

Position: ☐ reset in ground ☒ reset/level to existing base ☐ construct new base
☐ possible new base required ☐ stabilize foundation ☐ resquare

Treatment: ☐ core drill ☒ drill and pin ☐ simple adhesive repair ☐ injection grout
☐ replace bricks ☐ mortar ☐ repoint ☐ other:

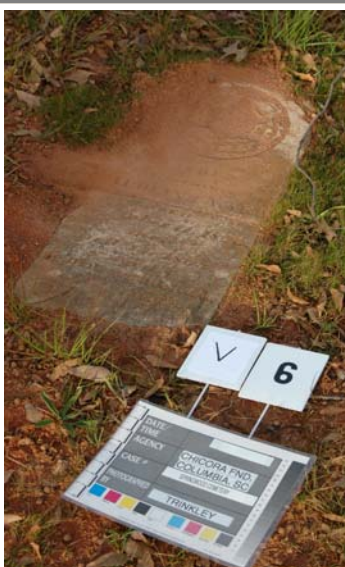
Position: ☒ fallen ☐ unstable ☐ tilted ☐ unattached/loose ☒ missing

Deterioration: ☒ broken ☐ cracked ☐ losses ☐ flaking/sugaring ☐ ferrous pins
☐ delamination/detachment ☐ missing fragments ☐ other:

Position: ☐ reset in ground ☐ reset/level to existing base ☒ construct new base
☐ possible new base required ☐ stabilize foundation ☐ resquare

Treatment: ☐ core drill ☒ drill and pin ☐ simple adhesive repair ☐ injection grout
☐ replace bricks ☐ mortar ☐ repoint ☐ other:

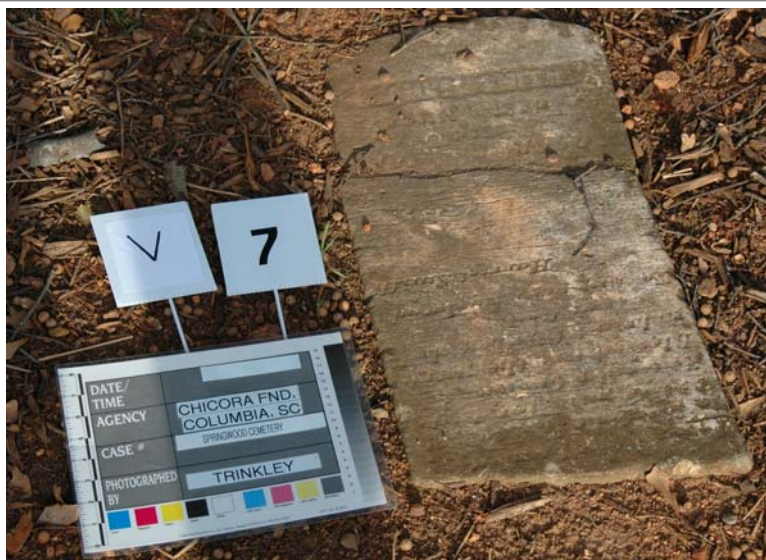
Position: ☒ fallen ☐ unstable ☐ tilted ☐ unattached/loose ☒ missing

Deterioration: ☒ broken ☐ cracked ☐ losses ☐ flaking/sugaring ☐ ferrous pins
☐ delamination/detachment ☐ missing fragments ☐ other:

Soiling: ☒ biological ☐ staining ☐ efflorescence ☐ other:

Position: ☐ reset in ground ☐ reset/level to existing base ☒ construct new base
☐ possible new base required ☐ stabilize foundation ☐ resquare
